FIBRE POSTS QUINT ESSENTIAL IN  
RESTORATIVE DENTISTRY – A CASE SERIES

J Odontol Res 2014;2(1):45-51

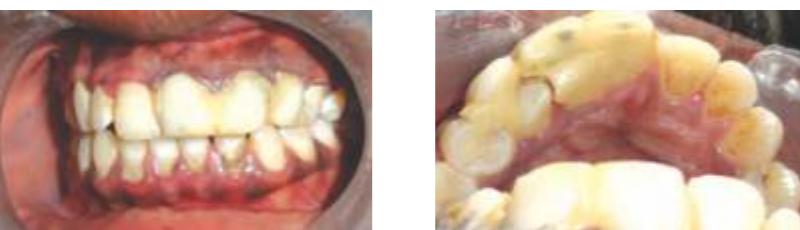
Figure 1,2. Labial and occlusal pre-operative view; improperly aligned self-cure acrylic crowns

A 26 year old male patient reported to Department of Endodontics with the chief compliant of unaesthetic crowns in the left upper anterior tooth region and wanted to restore them. On clinical examination it was found that the crowns in relation to the left upper central incisor, lateral incisor and canine were made of self cure acrylic crowns (Figure 1). It was also found that the crown over the palatally positioned left upper canine was not in proper alignment (Figure 2). Radiographic examination

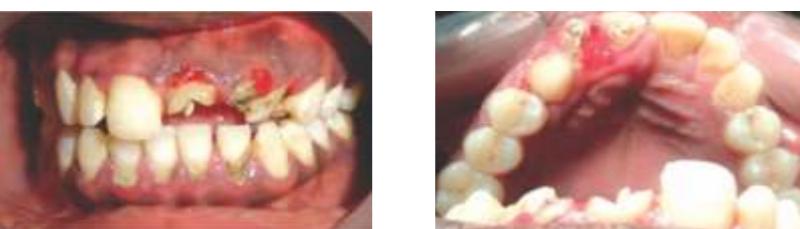
Figure 3, 4. Labial and occlusal preoperative view after removal of acrylic crowns

The ferrule effect height being 2mm above gingival margin and width being 2 mm (Figure 4&5)

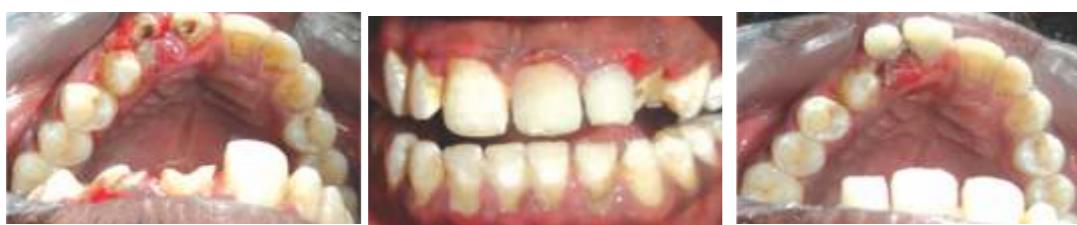
Figure 5. Prepared post space

Figure 6, 7. Fiber post luted with GIC; core buildup done with nano hybrid light cure composite in left upper central and lateral incisor

Following removal of the acrylic crowns along with the metal posts the root canal space in left upper central and lateral incisors were rechecked and confirmed radiographically that the canal space were free of any metal pieces and clear to receive a post. Root canal space were refined for post space preparation with peaso-reamer till size 3 (Figure 6). Fibre post was selected (Glass fibre posts, Produits Dentaires SA, Vevey, Switzerland) and fit tried, luted with glass ionomer cement. Core buildup was done with nano-hybrid light cure composite material (Meta-Biomed, Co., Korea) (Figure 7&8).

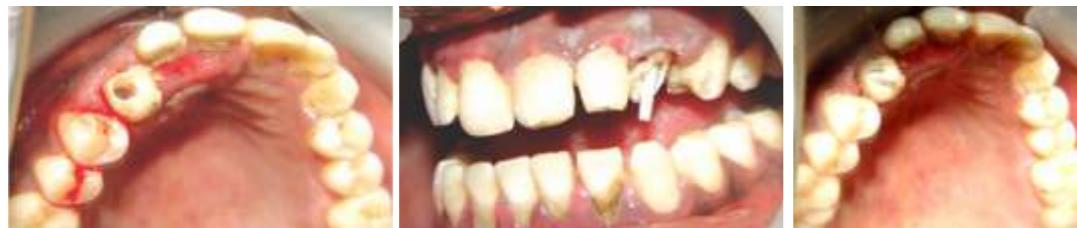
Figure 8, 9, 10. Endodontically treated left upper canine; labially prepared post space; fiber post placement

Left upper canine was endodontically treated. As the tooth was palatally positioned, post space was prepared labially and so the post placement in such a way that on core buildup left upper central, lateral incisors and canine were in line (Figure 9, 10&11). Crown preparation was done for ceramic crowns in left upper central and lateral incisors and canine (Figure 12&13). Ceramic crowns were luted with glass ionomer cement (Figure 14&15); patient was satisfied with the treatment outcome.

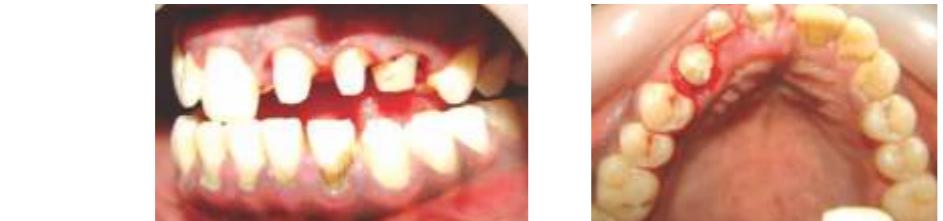
Figure 11, 12. Crown preparation – left upper central incisor, lateral incisor, canine

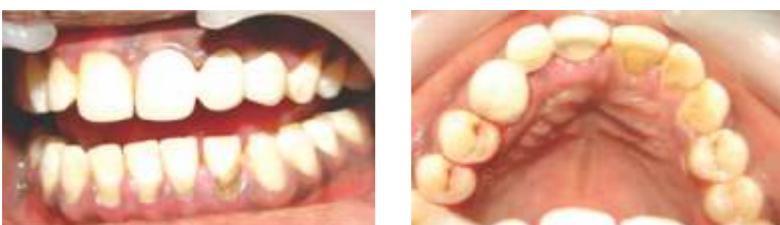
Figure 13, 14. Full ceramic crowns luted with GIC in left upper central incisor, lateral incisor, canine

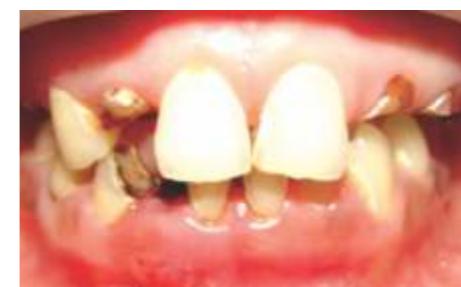
Figure 1. Labial and Occlusal Pre-operative View

anterior teeth. On clinical examination, it was seen that left upper lateral incisor and right upper lateral incisor and canine were grossly decayed and broken down (Figure 1). Based on Esteves et al. classification the broken down teeth were designated to Class II. The remaining tooth structure of broken down anterior teeth had the following criteria,

The ferrule effect height being 2mm above gingival margin and width being 2 mm (Figure 1)

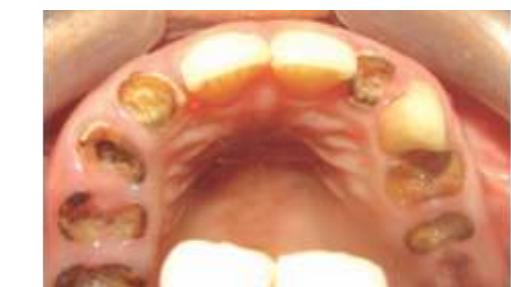
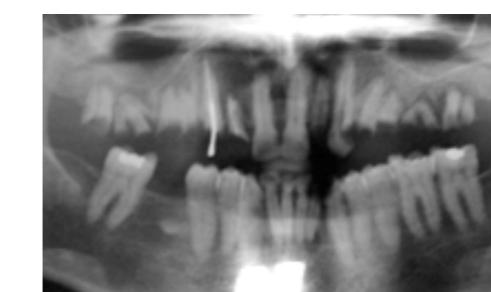
Figure 2. Radiographs showing sufficient root length and satisfactory endodontic treatment

The root length gingival to alveolar crest being greater than crown height plus 3 mm (Figure 2) and

Endodontic condition being satisfactory (Figure 2).

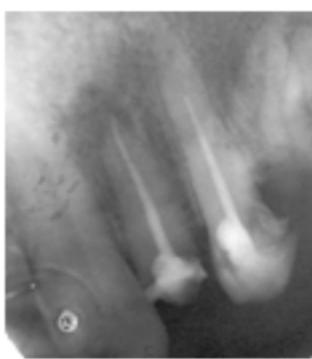
Figure 3. Fibre post placement in right upper lateral incisor, left upper lateral incisor and canine.

Following root canal treatment for the left upper lateral incisor and right upper lateral incisor and canine, post space preparation was done using peaso-reamer till size 2 for lateral incisor and size 3 for canine. Fibre post was selected and fit was tried and luted with glass ionomer cement (Figure 3). Core build up was done using nano-hybrid light cure composite (Meta-Biomed, Co., Korea) (Figure 4). Crown preparation was done for ceramic crowns in left upper canine and lateral incisor, right upper lateral incisor and canine (Figure 5). Ceramic crowns were luted with glass ionomer cement; patient was satisfied with treatment outcome (Figure 6).

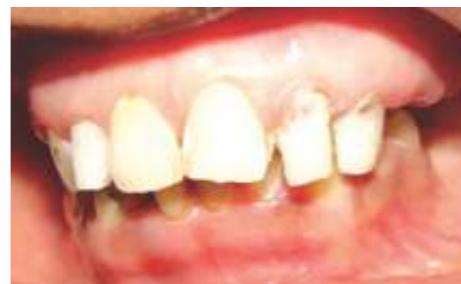
Figure 4. Core build up using nano hybrid light cure composite

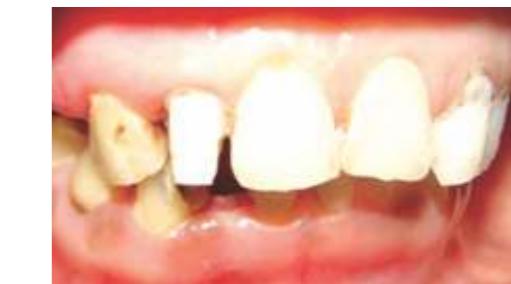
Figure 5. Crown preparation in left upper lateral incisor, right upper lateral incisor and canine

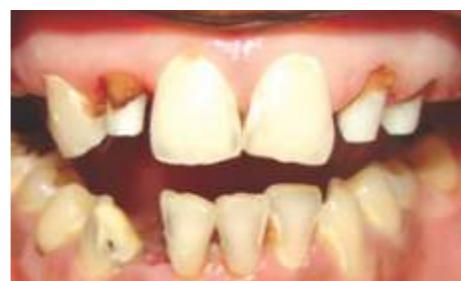
Figure 6. Full ceramic crowns luted in left upper lateral incisor, right upper lateral incisor and canine

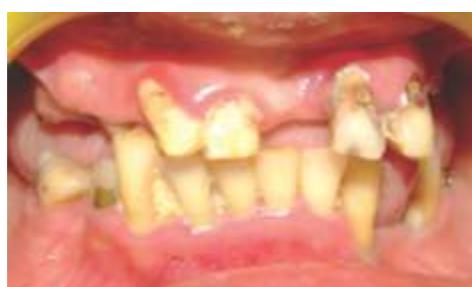
Figure 7. Labial and occlusal preoperative view

A 64 year old female patient reported to Department of Endodontics with chief complaint of broken down and missing teeth. On clinical examination, had missing right upper central incisor and left upper canine and grossly broken down left and right upper first and second premolars (Figure 7). Based on Esteves et al. classification the broken down teeth were designated as class II. The remaining tooth structure of broken down upper first and second premolars had following criteria,

margin and width being 2 mm (Figure 7)

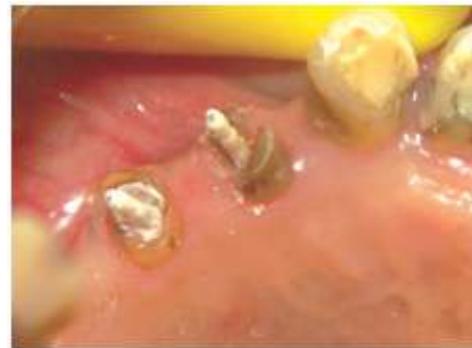
Figure 9. Fibre post placement in right and left upper first and second premolar

Following root canal treatment of right and left upper first and second premolar teeth post space preparation was done in the palatal canal till peaso-reamer size 2. Fibre post was selected, tried into post space prepared and lute with glass ionomer cement (Figure 9). Core build up was done using nano-hybrid light cure composite (Meta-Biomed, Co., Korea) (Figure 10). Crown preparation was done in right upper canine, lateral incisor, left upper central incisor and left and right first and second upper premolars (Figure 11). Ceramic crown and bridge were luted with glass ionomer cement; patient was satisfied with treatment outcome (Figure 12).

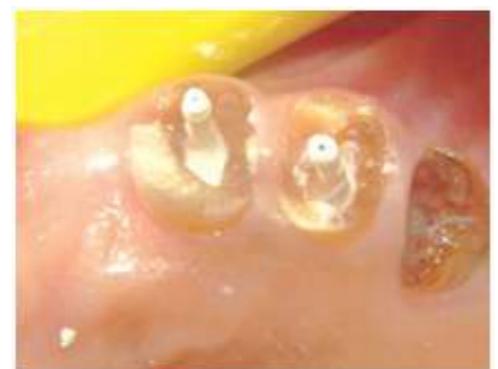
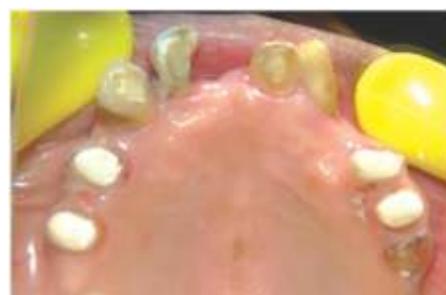
Figure 10. Core build up in right and left upper first and second premolar

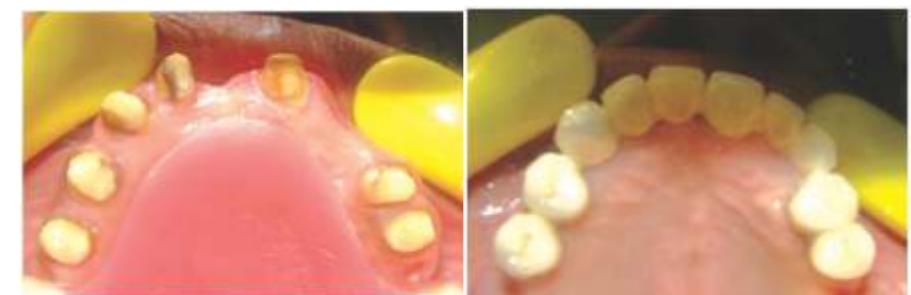
Figure 12. Ceramic crowns luted in right upper canine, lateral incisor, left upper central incisor and left and right first and second upper premolars
