ORIGINAL RESEARCH ARTICLE

A COMPARATIVE EVALUATION OF EASY REMOVAL OF DENTAL CASTS FROM ALGINATE IMPRESSIONS USING DIFFERENT BRANDS OF DENTAL STONE - AN IN VITRO STUDY

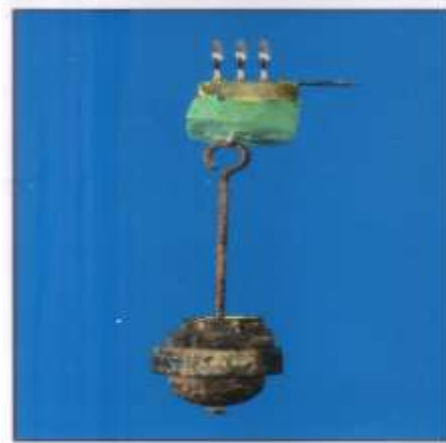
1. Static loading: The entire apparatus was hung on to the iron rod using the three metal hooks on the tray. A load of 5 kilogram was applied initially for a period of 5 seconds. The load was gradually increased till the cast was dislodged from the impression. The load required to dislodge the impression was recorded in Table 1. Twenty such samples were tested.

Fig1: Figure showing static loading test

Table 1 presents the load applied in the static loading test for all the three different brands of dental stone. Eurostone needed an average of only 20 kilogram, Goldstone needed an average of 26.95 kilogram and Dentstone an average of 27 kilogram to dislodge from the alginate impression.

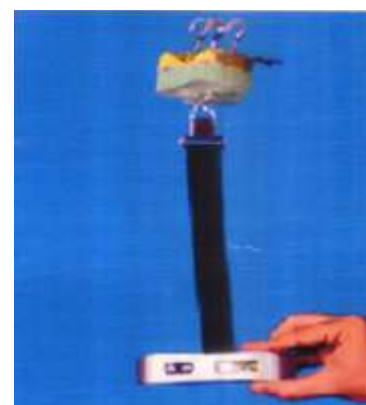
Using an electronic luggage scale (Camry, ISO 9001:2008, Model EL10) the stone cast was pulled down from the impression and the load was recorded on the electronic digital scale. The values were recorded in Table 2. Twenty such samples were tested.

Fig 2: Figure showing load application by digital electronic luggage scale

Table 2 presents the load applied by a digital electronic luggage scale to remove the dental stone cast from the alginate impression. Eurostone showed an average of 24 kilograms, Goldstone an average of 30.05 kilograms and Dentstone an average of 31.7kilogram.

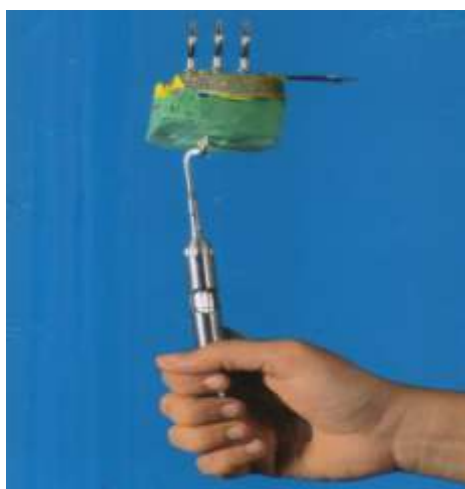
The similar type of samples and apparatus were subjected to a load applied by intermittent loading using a crown remover. The crown remover used was of the pneumatic type (Automatic crown remover, marketed by Ashoo sons, Delhi). The number of strokes for removal of cast from the impression were counted and recorded in Table 3. Twenty such samples were tested.

Fig 3: Figure showing intermittent loading using crown remover

Table 3 presents the number of strokes applied by the crown remover to dislodge the cast from the impression. Eurostone showed an average of only 21 strokes, Goldstone an average of 28 strokes and Dentstone an average of 30 strokes.
